Brine well incident report

Welcome to a special edition of *infocus* in which we share with you the findings of our technical assessment into the Brine Well 45 incident which happened on 18 June 2011 and the additional safety and security measures that have been taken as a result.

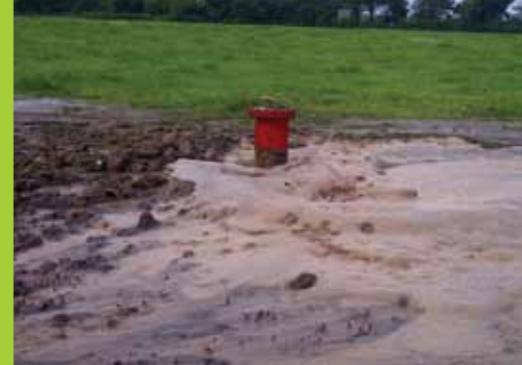
1. Brine flowing from the area surrounding the red wellhead casing

A In the early morning of Saturday 18 June, brine and air was ejected from the area immediately surrounding Brine Well 45 in what is commonly referred to as a 'blow out'. The brine mixed with the soil around the wellhead casing and flowed downhill to Back Lane causing the area to flood and the lane to be closed. The air and brine flow eroded the soil surrounding the casing causing a hole to develop which then filled with brine. At first, air bubbled vigorously to the surface before gradually subsiding and then stopping altogether at around 9pm that evening.

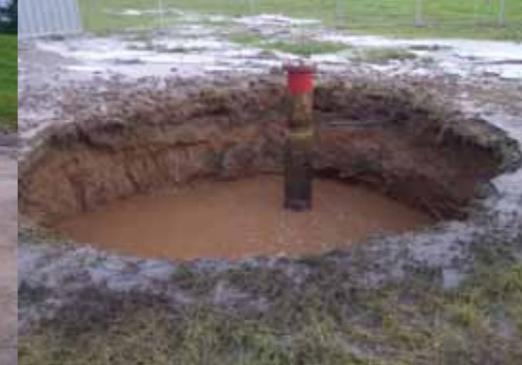
2. The air and brine flow eroded the soil surrounding the casing causing a hole to develop which filled with brine

A Our investigations show that a short section of borehole casing was distorted and ruptured in an airlock in the brine well 190 metres below ground. This caused air and brine to rise up under pressure to the wellhead. However, the wellhead flange (the disc-shaped top which secures the wellhead) was able to withstand the increase in pressure. Highly pressurised brine and air travelled back down the gap that exists between the inner and outer casings and then back to the ground surface around the outside of the outer casing.

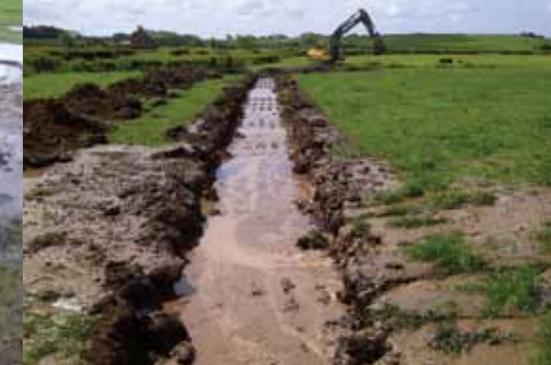
3. One of the trenches dug to intercept the brine and soil flow

A We quickly began working closely and co-operating fully with all the relevant agencies including the Environment Agency, Lancashire County Council, Wyre Borough Council and the Health & Safety Executive. Emergency mitigation and management measures undertaken at this time included digging a trench in the field above Back Lane to intercept brine and soil flow, erecting security fencing, beginning clean-up operations and arranging for both geological and environmental advisors to be on site.
